M2021046 Dawson Gold Mine Surface Water Contamination Risk

From Proposed Zephyr Minerals Mine, Fremont County, Colorado

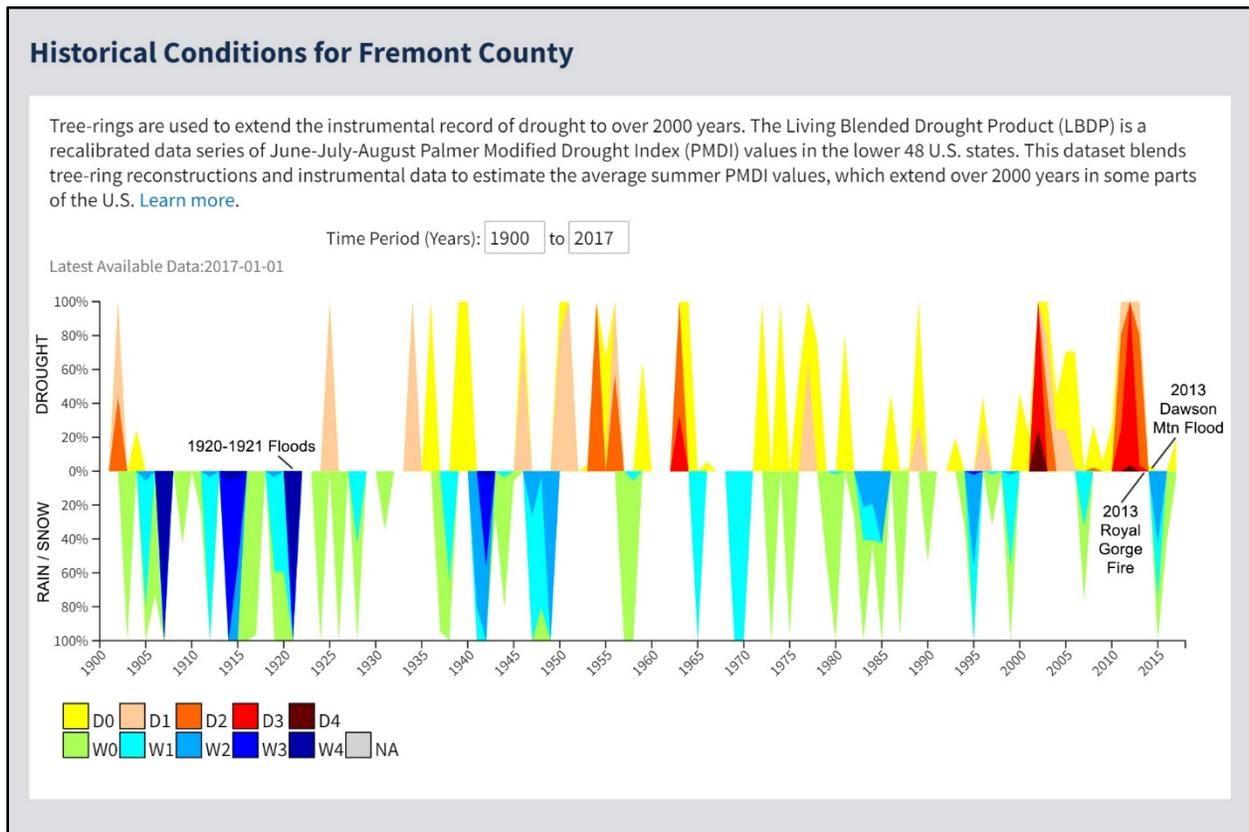
NOAA-National Integrated Drought Information System (NIDIS) at Drought.gov

Fremont County weather vacillates from severe drought to sudden downpours where dry washes become impassible torrents of water. So much has been written about the great Pueblo Flood of 1921 that few remember that Fremont County experienced seven flood events in one year. Rainfall on the low-permeable mountain rock cascaded quickly down the slopes. A couple of inches of rain over one to three hours produced extensive flooding.

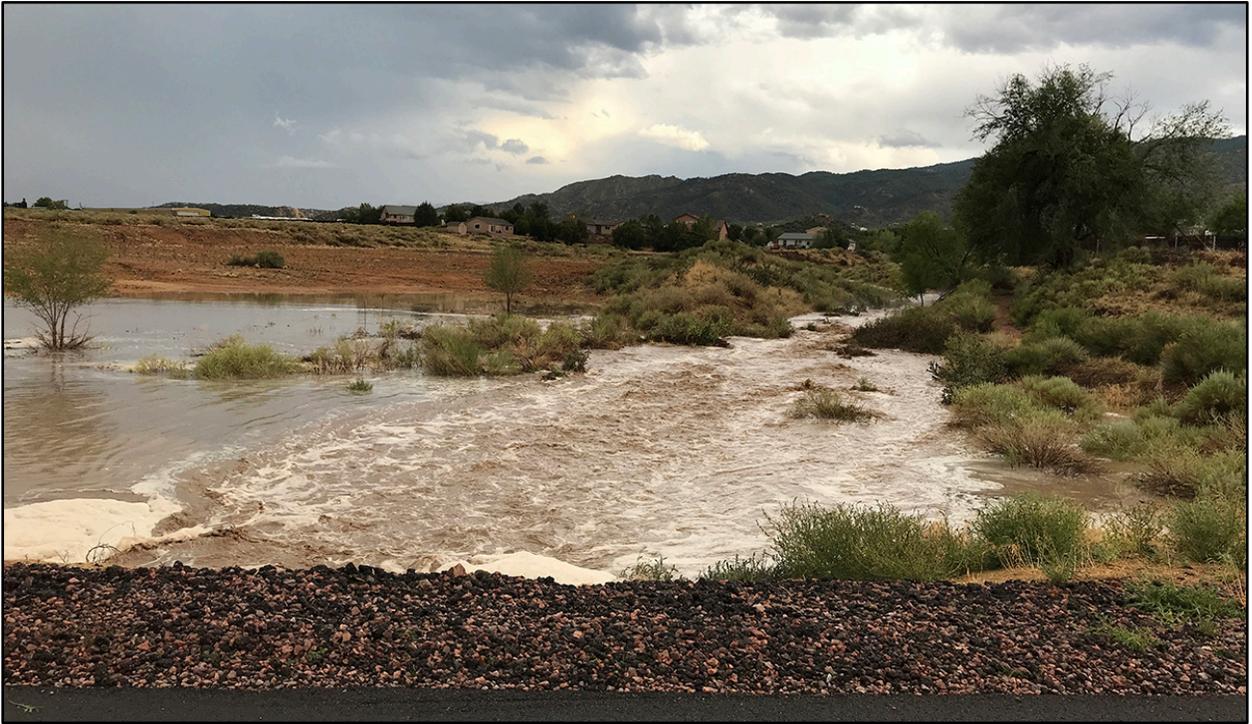
July 23, 2018, a rainstorm produced flooding through a normally dry area

On July 23, 2018, a rainstorm on Dawson Mountain flooded the communities on the mountain's slopes. Wind speeds measured more than 90 mph before the power went out. Rainfall measured at a rate of approximately 5 inches per hour.

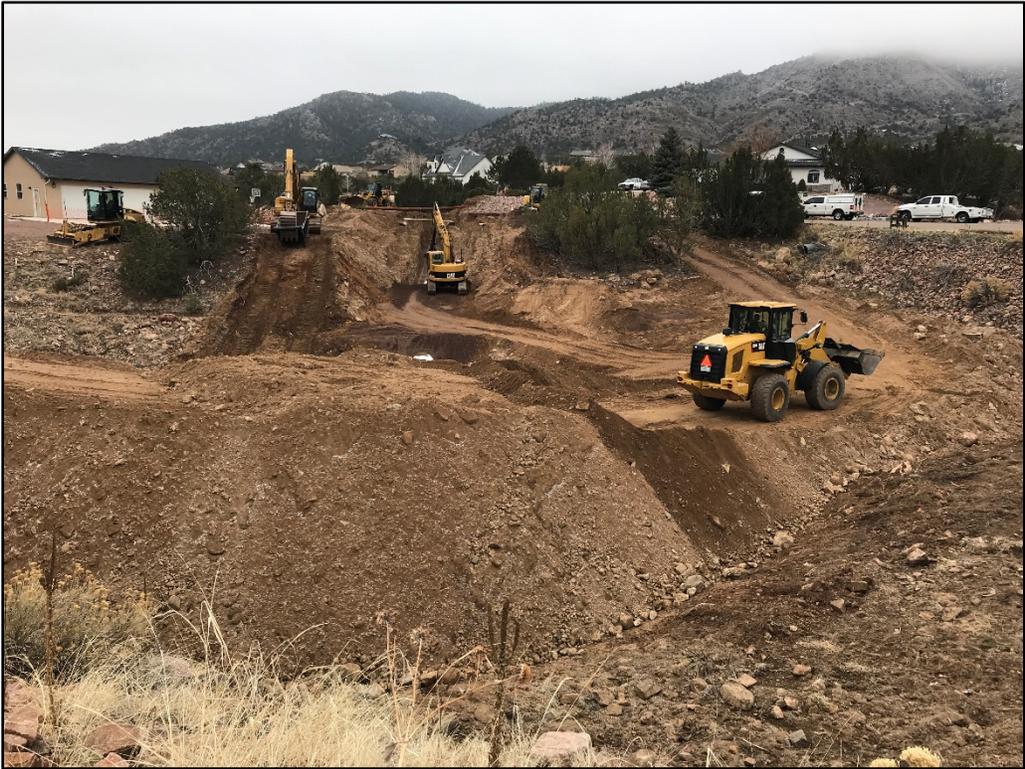
2020-2021 Drainage improvement project

In 2018, the City of Cañon City used \$214,731 from the Stormwater Fund on drainage repairs. In 2020-2021, an additional \$1,081,074 was spent for a 30% improvement of stormwater drainage and holding ponds. The funds were approved because this type of weather event was likely to happen again.

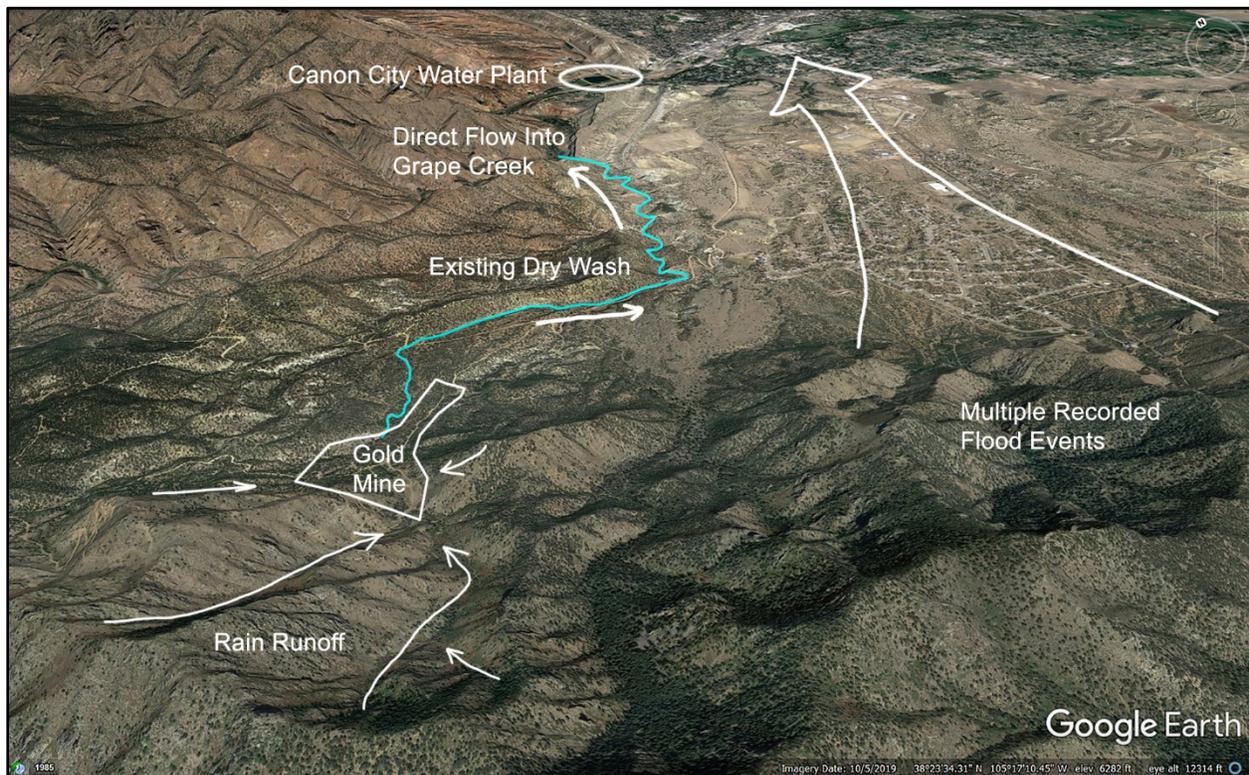
Comparison of multiple recorded Dawson Mountain floods to future mining site runoff

The proposed mine lies within the watershed of Grape Creek. Drainage from Dawson Mountain runs through the middle of the proposed mining facility and into an existing wash that empties into Grape Creek, 2.5 miles away. A heavy rain event could wash contaminants from the mining site into Grape Creek. Roughly one mile downstream from this point, Grape Creek enters the Arkansas River. One-half a mile further downstream is the City of Cañon City Water Department (CCWD) water intake.

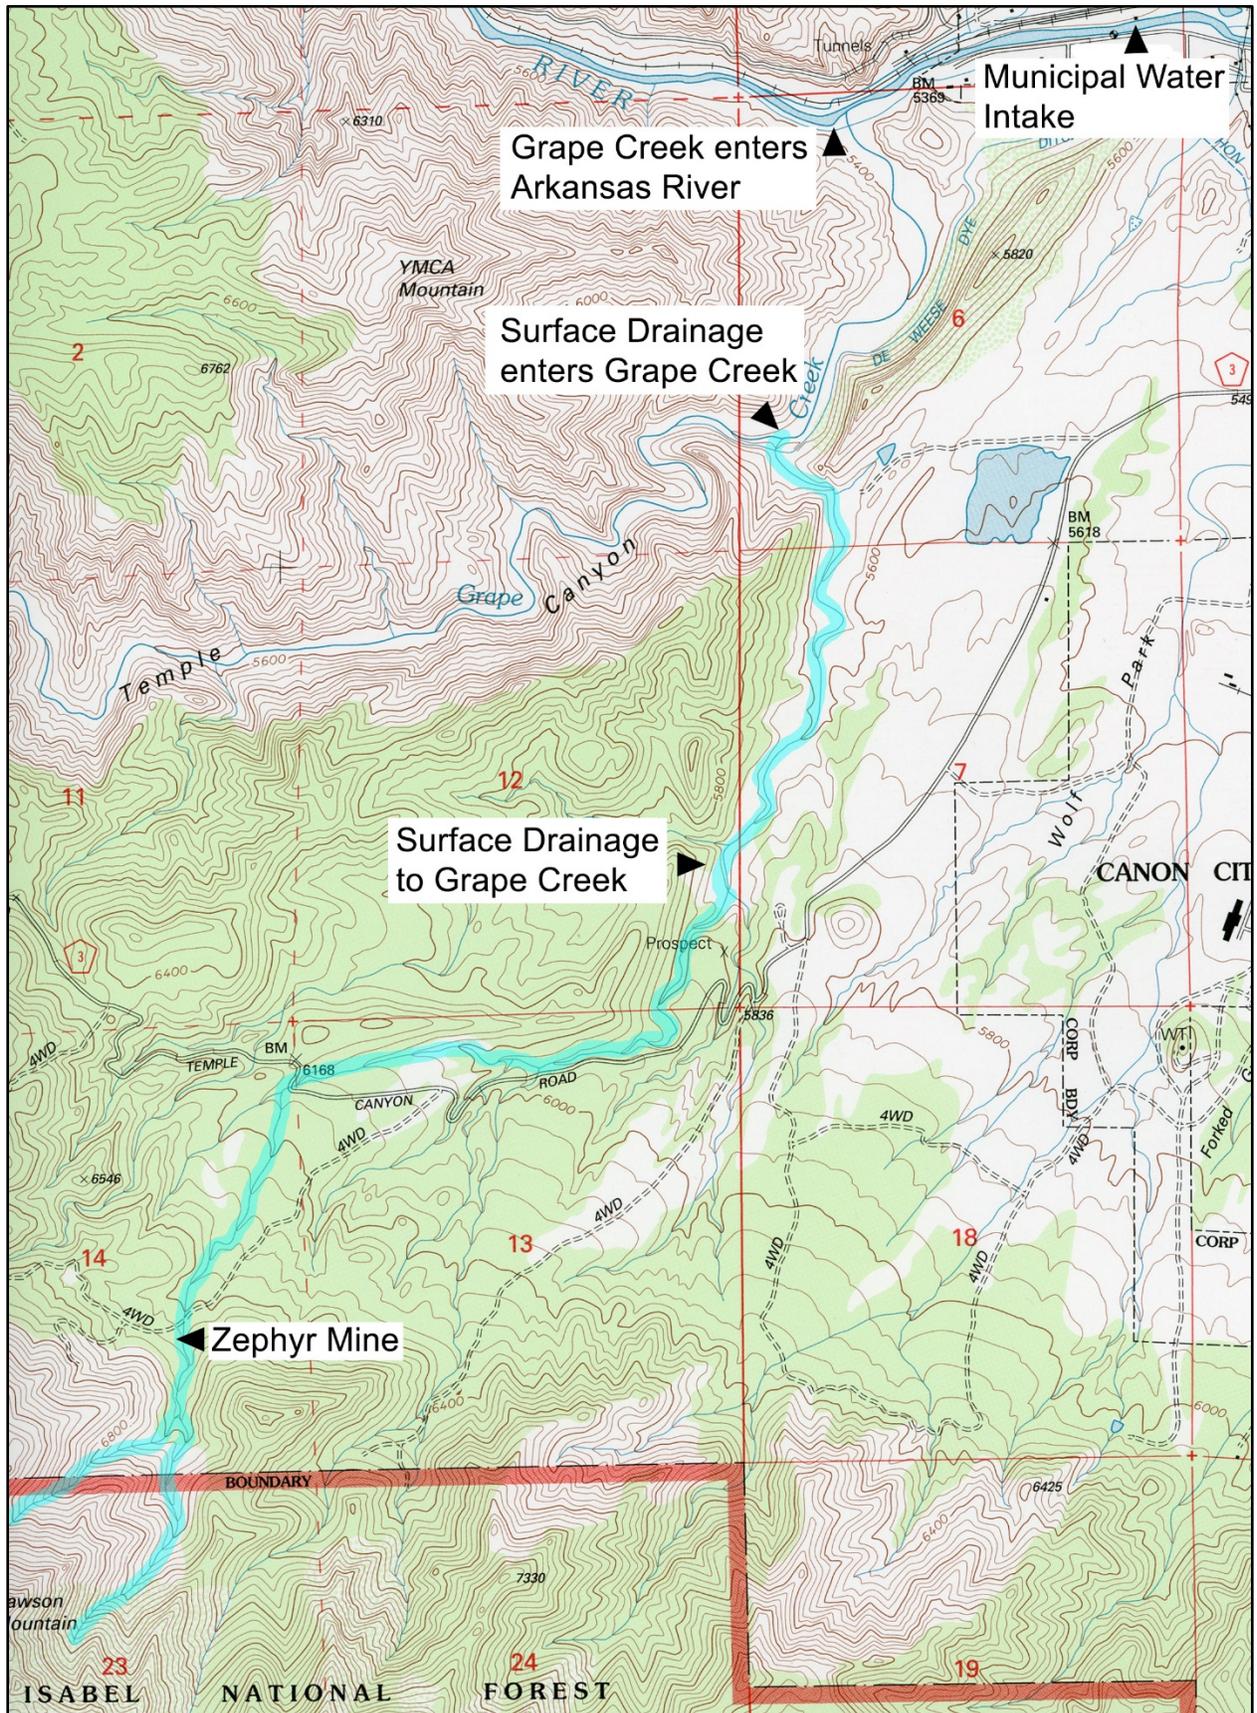
USGS Contour Map: Royal Gorge Quadrangle

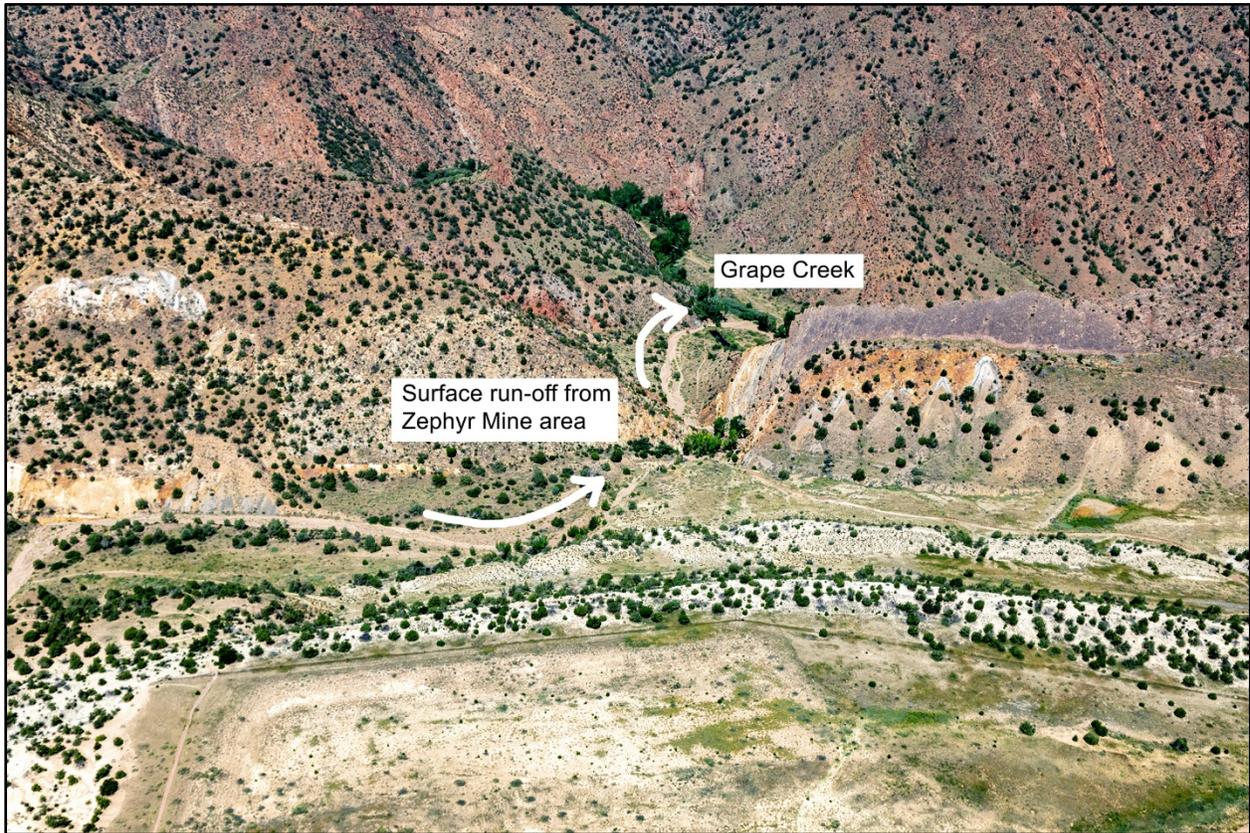
Existing dry wash flowing from Zephyr Minerals Gold Mine area directly into Grape Creek

The proposed mine lies within the watershed of Grape Creek. Drainage from Dawson Mountain runs through the middle of the proposed mining facility and into an existing wash that empties into Grape Creek, 2.5 miles away. A heavy rain event could wash contaminants from the mining site into Grape Creek. Roughly one mile downstream from this point, Grape Creek enters the Arkansas River. One-half a mile further downstream is the City of Cañon City Water Department (CCWD) water intake.
